# THE USE OF DIGITAL PHOTOGRAPHS TO QUANTIFY VEGETATION GROUND COVER IN DEGRADED AREAS

## ABSTRACT

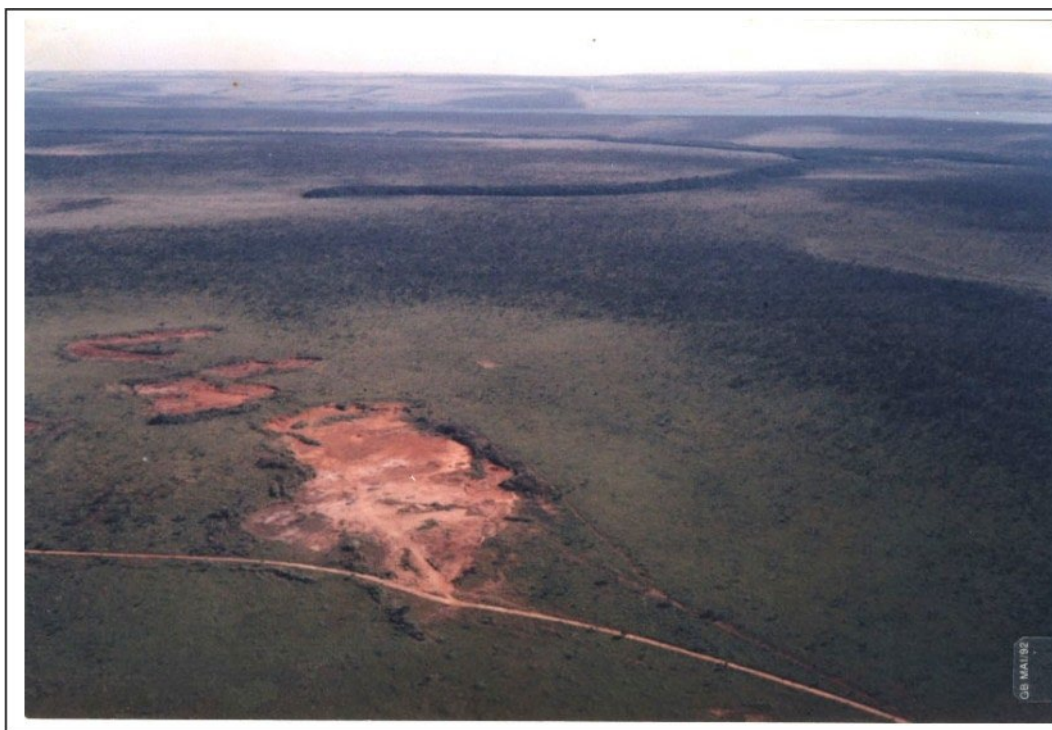
**Figure 1:** Aerial view of the gravel pit where an experiment aimed at developing methodology to reclaim mined land with savannah species were implemented in 1992. The area is located in the National Park of Brasília, Federal District of Brazil

The site studied is located at the National Park of Brasília, Federal District, Brazil, and covers an area of approximately 6 hectares (Figure 1). Gravei was extracted from the area in the early 60's. The original savannah vegetation of the site was removed and the mineral was extracted up to a 2 meters depth. Nothing was done for almost 30 years to reclaim the mined area. As a consequence, the surface of the gravei pit remained bared, without vegetation cover.

For results from research conducted in the experimental site Figure 1, published since 1992, see Leite et al (1992), Martins (1996), Leite et al. (1994), Baptista & Leite (1997), Martins et al. (2001).

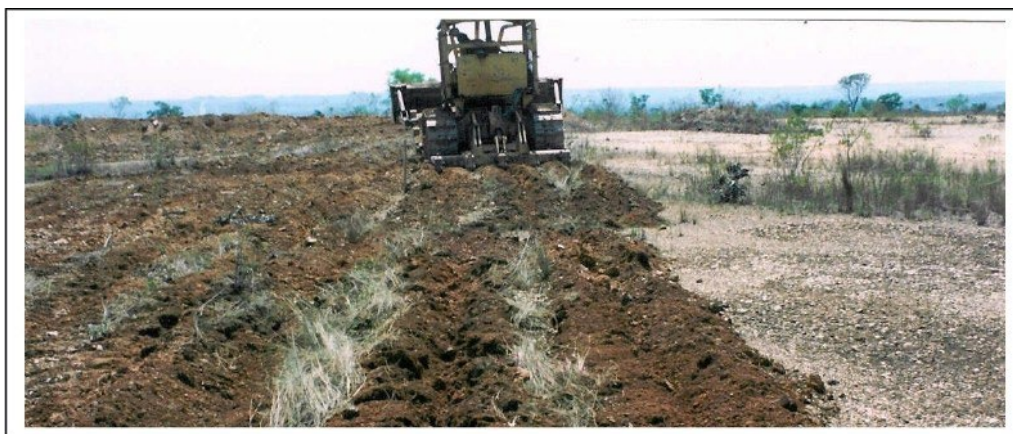
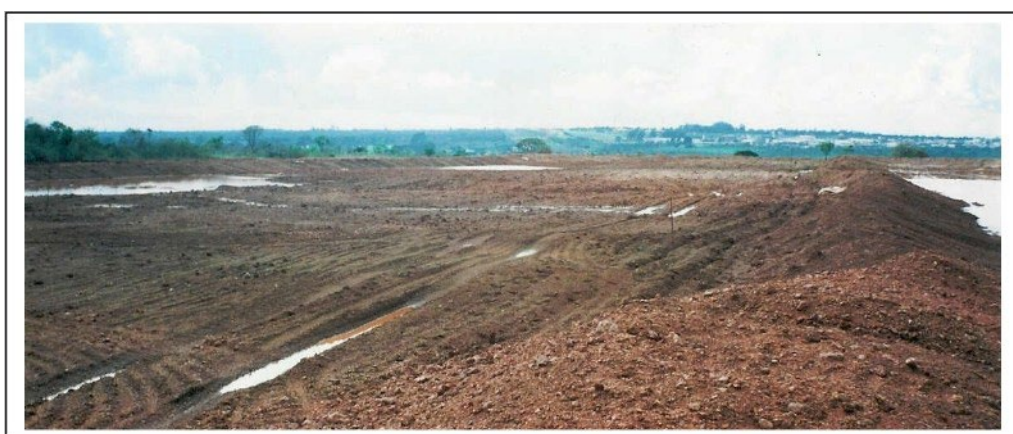
**Figure 2:** Details of the substrate preparation (A and B) and the experimental design (C) employed in the original research, which was established in 1992

In 1992, as part of a research project supported by the Brazilian Institute for Environment and Natural Renewable Resources (IBAMA), conducted by members of the research staff of the Ecology Department of the University of Brasília, soil conservation measures, including terracing, subsoiling and manuring were realized in the area (Figures 2 a,b). Experimental design of the 1992 research, including size of plots, treatments and replications is illustrated in Figure 2c.

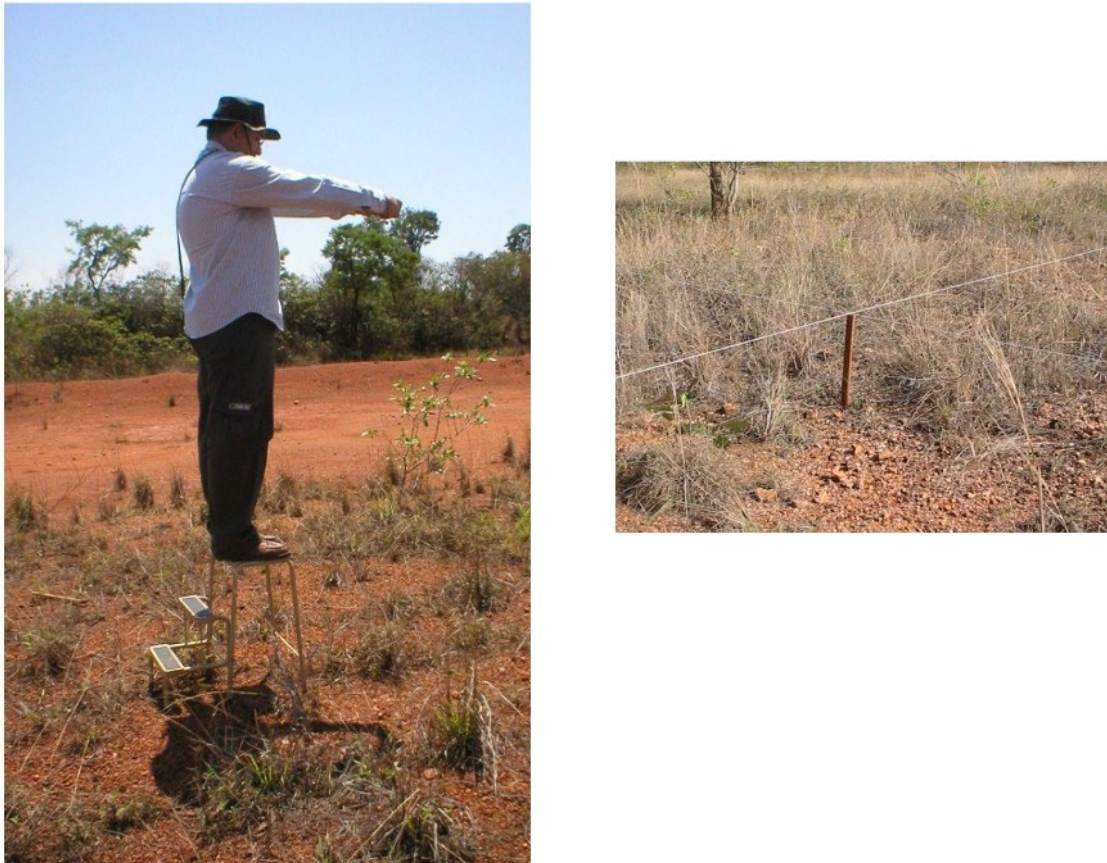
**Figure 3:** Photographer taking pictures from approximately 2.10 meters high with a digital camera and, on the right, details of the demarcation of the centre of each experimental plot

A portable Canon camera (model Power Shot A 100) was used to take digital photographs of the experimental site. Photographs from approximately a 2, 10 meters high, perpendicular to the ground, were taken of the centre of the 24 experimental plots on the 11th of October of 2003, in a sunny day (without clouds), from 10 to 12 am. The same photographer took all the 24 photographs used to assess the vegetation ground cover (Figure 3).
